# Geologic Report on the Slide near Budge Drive, Jackson, Wyoming to the Jackson Town Council by the Geologists of Jackson Hole

## Abstract

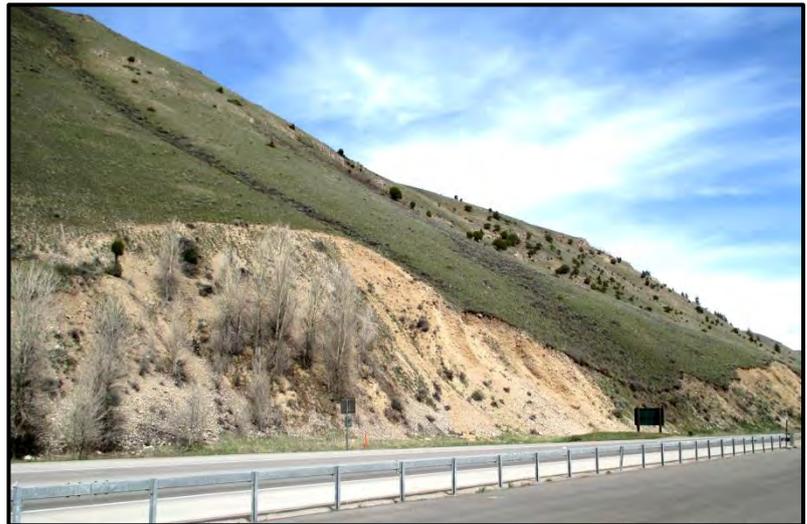
**Figure 3: East slope of East Gros Ventre Butte just north of the Jackson town line along Highway 89 showing a typical slope and removal of buttress material to build the highway.**

The buildup of these colluvial-alluvial aprons is clearly observed, for example, along Highway 89 just north of the town boundary (Figure 3) where the road cuts through several colluvial-alluvial debris fans. Figure 3 shows that part of the rocks and debris holding up the original slope has been removed in the process of building Highway 89, decreasing the stability of the whole slope, making it more at risk for land slumping or sliding. The angle of repose of the cut face is now dependent on the internal coherency of the poorly consolidated debris. Any removal of rock and soil debris (colluvium) from the lower slope of colluvial-alluvial aprons to grade a highway or create a building pad compromises the stability of the whole slope. The result is that over time an altered slope such as that seen in Figure 3 is much more likely to settle or slide in order to re-establish a more stable configuration with respect to gravity.

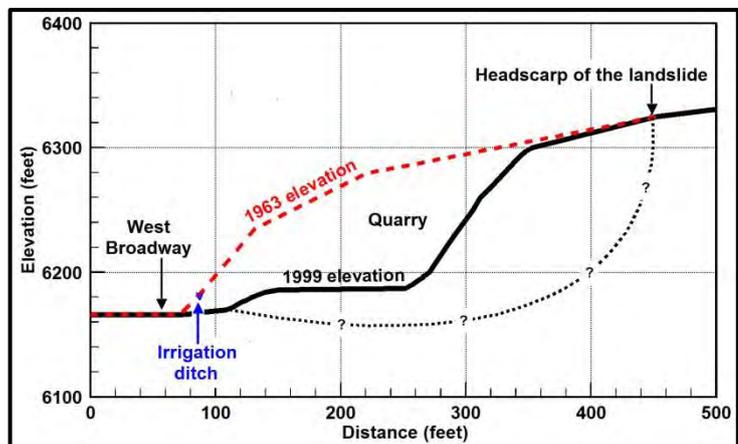
Figure 4: Topographic cross-section from south to north from West Broadway just east of Budge Drive through the house destroyed at the top of the headscarp of the landslide. The dashed red line shows elevations in 1963. The black line shows elevations in 1999 after quarrying.

A more detailed topographic profile is shown in Figure 4 from West Broadway northward to the house at 1045 Budge Drive that was destroyed straddling the headscarp of the landslide. The black line is based on one-foot 1999 topographic data and the dashed red line on the 1963 USGS topographic map with 40-foot contours. The dotted black line with question marks in it shows a rough approximation of the slip surface along which the rocks and debris above most likely slid dramatically in April, 2014. Note that the cross-section of rock quarried is approximately equal to the cross-section of rock that has recently slid.

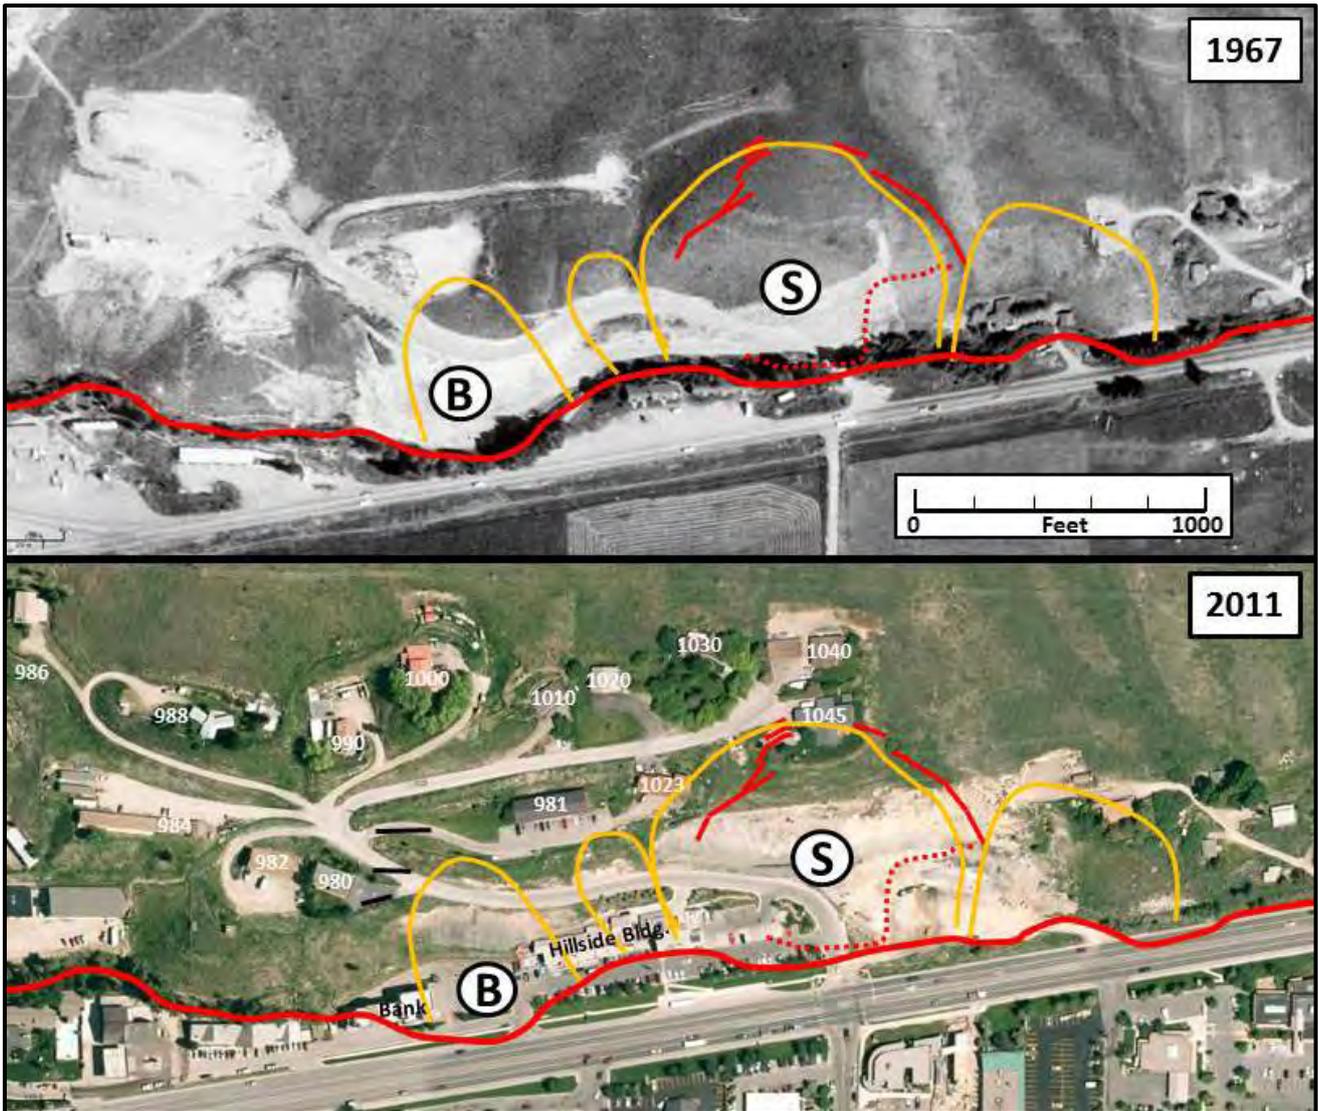
The long red line in Figure 12 traces The Little Gros Ventre Irrigation Ditch dug by the original homesteaders of this region before 1910. The ditch runs from where Flat Creek flows under West Broadway at an altitude of 6195 feet to fields west of Highway 22 just north of the intersection with West Broadway at an altitude of 6180 feet. This ditch is shown most clearly by the row of mature trees seen in the 1955 aerial photo (Figures 6 and 7). Parts of the ditch were piped underground as development increased north of West Broadway. The system was last used in 1987 and large parts were removed in 2003 with the development of the Hillside Building at 945 West Broadway. The depth of the ditch is unknown but was most likely shallow since it must have been dug by hand or by horse-drawn implement. This creates an excellent reference for ground level elevation prior to development. Water in the ditch formerly flowed in the vicinity of Budge Drive at an elevation of approximately 6187 feet (average of the elevations at both ends). This is 10 feet above the southern edge of the Walgreen building currently at an elevation of 6177 feet, which is ten feet

Figure 12: Air photographs of the Budge Drive region taken in 1967 and 2011. The long red line marks the position of the irrigation ditch as shown in Figure 7. The orange arcs show the location of the geomorphic anomalies shown in Figure 7. The dashed red line shows the southern limit of deformation observed in April, 2014. The short red lines show ground fracturing observed in April, 2014.

On November 15, 2013, an opening crack was discovered along the upper west part of the developing slide (Figure 12) and reported to the town. Residents of 1045 Budge Drive moved out soon thereafter. In early December, 2013, local residents reported a 2 to 3 inch crack in the concrete retaining wall just north of lower Budge Drive according to the Jackson Hole News and Guide. Workers installed a steel net over the cliff in December in order to make it more difficult for rocks to fall out into the parking lot. By December 16, 2013, several cracks had opened up in the driveway and crawl space at 1045 Budge Drive.

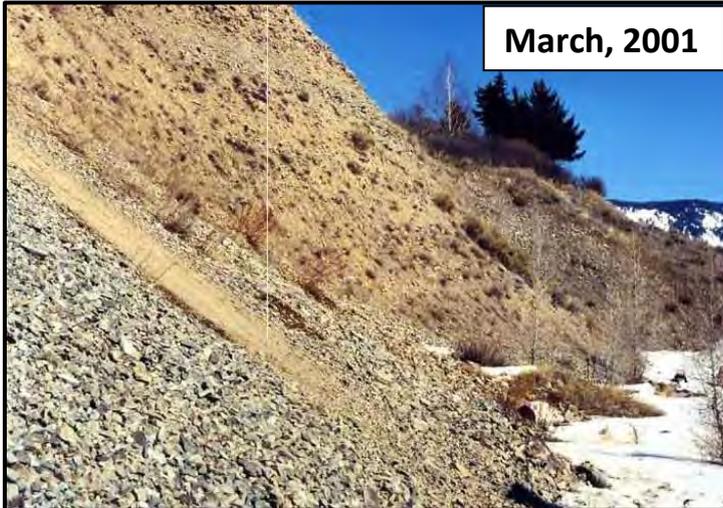
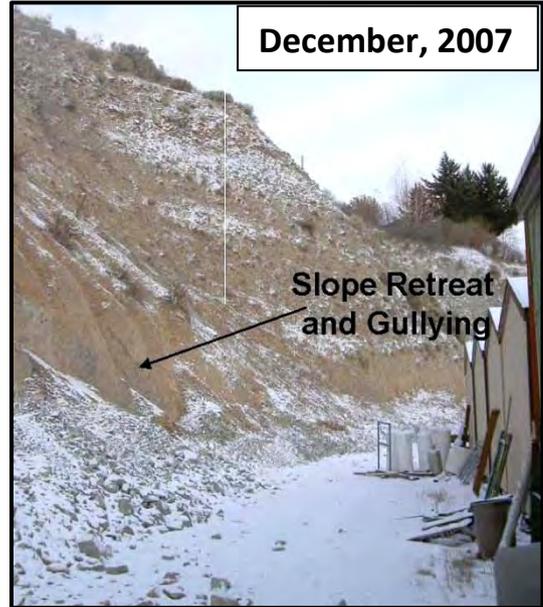
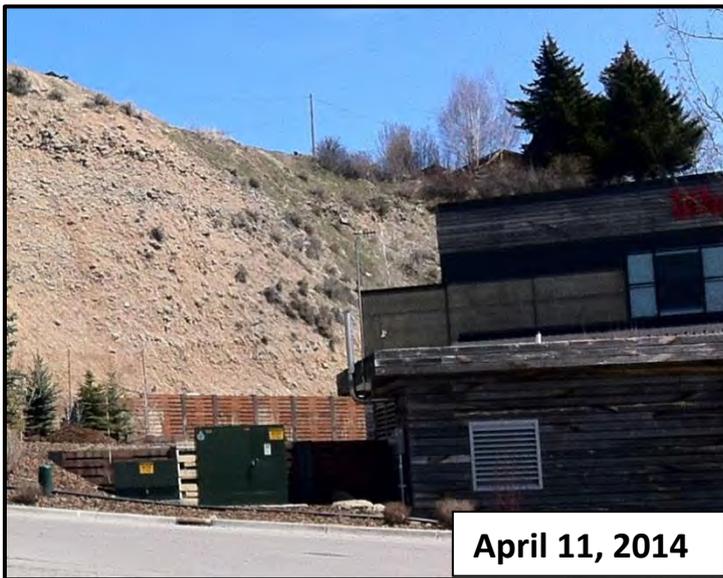
Figure 13: Photos of the northeast corner of the property developed for Walgreens. Note the trees in the upper right corner of each photo for comparison of views. Upper two pictures from the Geotechnical Report by Womack and Associates December 20, 2007. Photo to left by Ulrich. Lower photo from the website of the Town of Jackson.

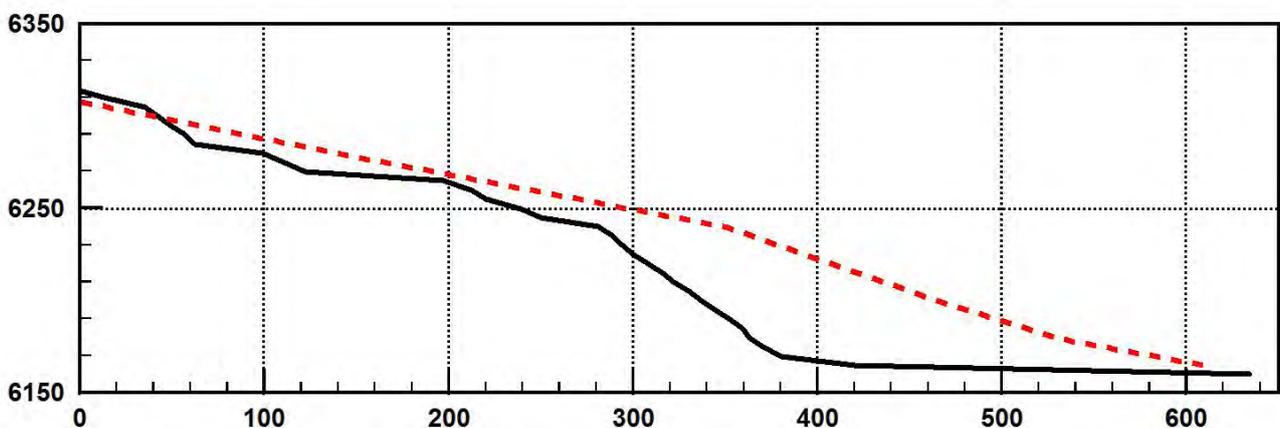
Figure 14: Topographic profile north-northwest to south-southeast through the circled B in Figure 12. The black line shows 1999 topographic data. The dashed red line shows topographic data from the 1963 USGS Jackson Quadrangle map.

and its parking area to the East shown by the circled B in Figure 12. Figure 14 shows a profile through the circled B in Figure 12. The area of the cross-section removed is approximately 10,000 square feet. Assuming a width of 500 feet, the volume removed approaches 5 million cubic feet. The remaining slope is unsupported except for a 7-foot high retaining wall at its base.

The second greatest amount of rock and debris removed since 1960 from north of West Broadway, after the County Quarry, was in the region today of the Bank of Jackson Hole branch and the parking lot between the bank and the Hillside Building. Cracks have already been observed to form above these steep slopes in Budge Drive and nearby driveways following malfunction of a major sprinkler system. Ways to improve the stability of these steep slopes and to divert and control runoff should be considered carefully.

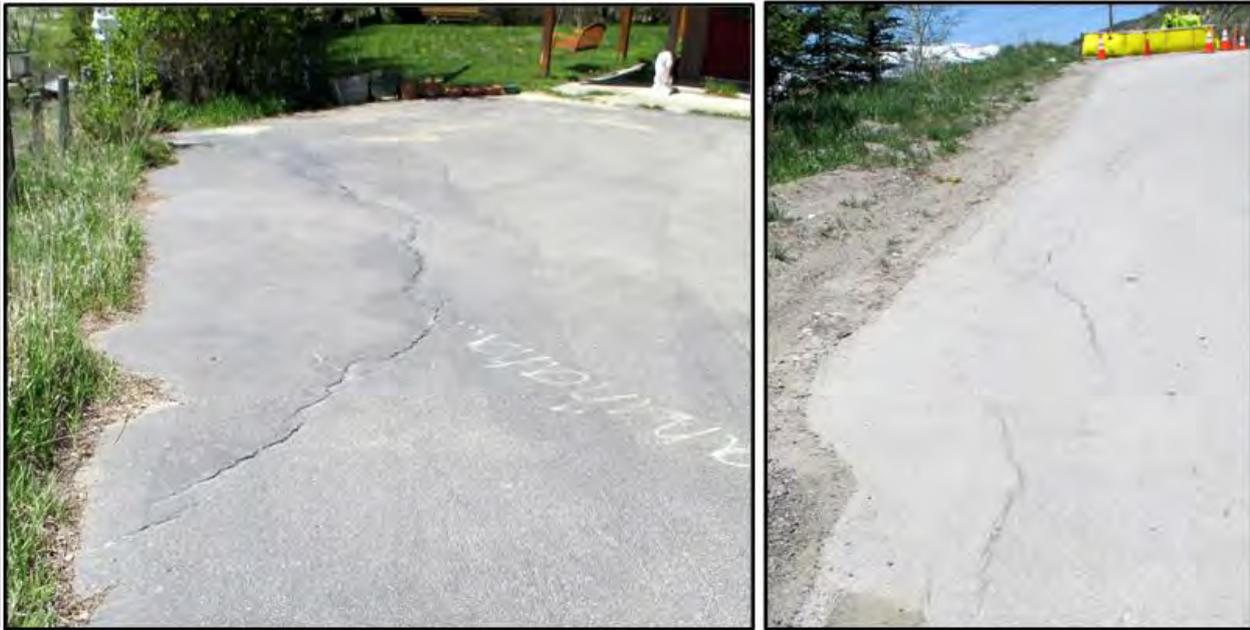
Figure 15: Crack in the driveway at 980 Budge Drive (left) and just to the north along Budge Drive (right) that were first observed in 2009 shortly after a malfunction of the sprinkler system for the condominiums at 981 Budge Drive caused considerable water to flow down the hill. Views looking west.

Small cracks in the pavement (Figure 15 and 16, black lines in Figure 12) were first observed by the residents at 980 Budge Drive near the south edge of their driveway, in Budge Drive itself just to the north, and in the driveway to 981 Budge Drive during 2009, shortly after some malfunction with the sprinkler system at the condominiums at 981 Budge Drive caused considerable water to flow down the hill. These cracks have not been observed to grow since 2009 but should be monitored, at least by carefully sealing them to prevent inflow of water and then keeping a watch out for new or renewed cracking. Budge Drive just north of the circled B and nearby homes appear to have a higher risk of slope failure than anywhere else on the hill after the Budge Slide is stabilized. Increased stabilization of this area together with developing systems to divert and control runoff should be considered as part of efforts to stabilize the Budge Slide.

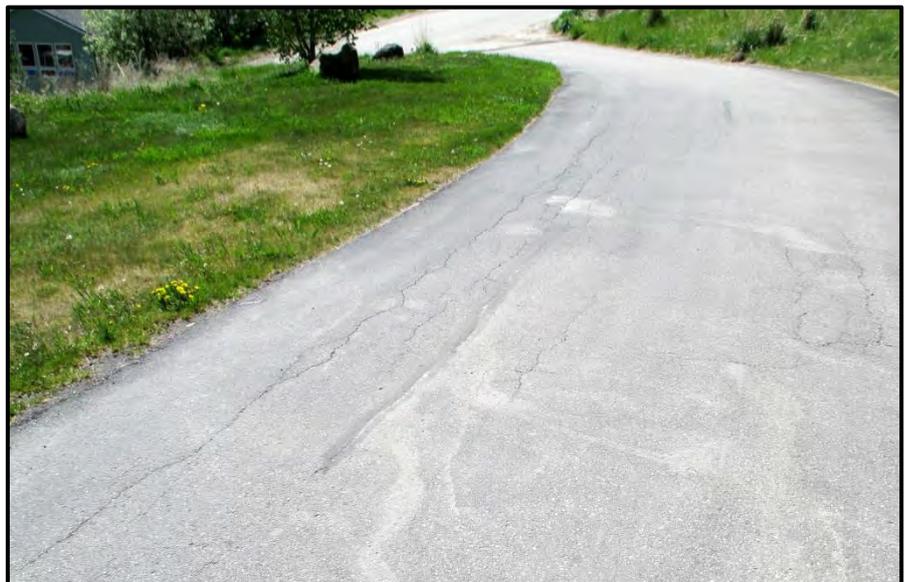
Figure 16: Cracks in the driveway to the condominiums at 981 Budge Drive, looking west.

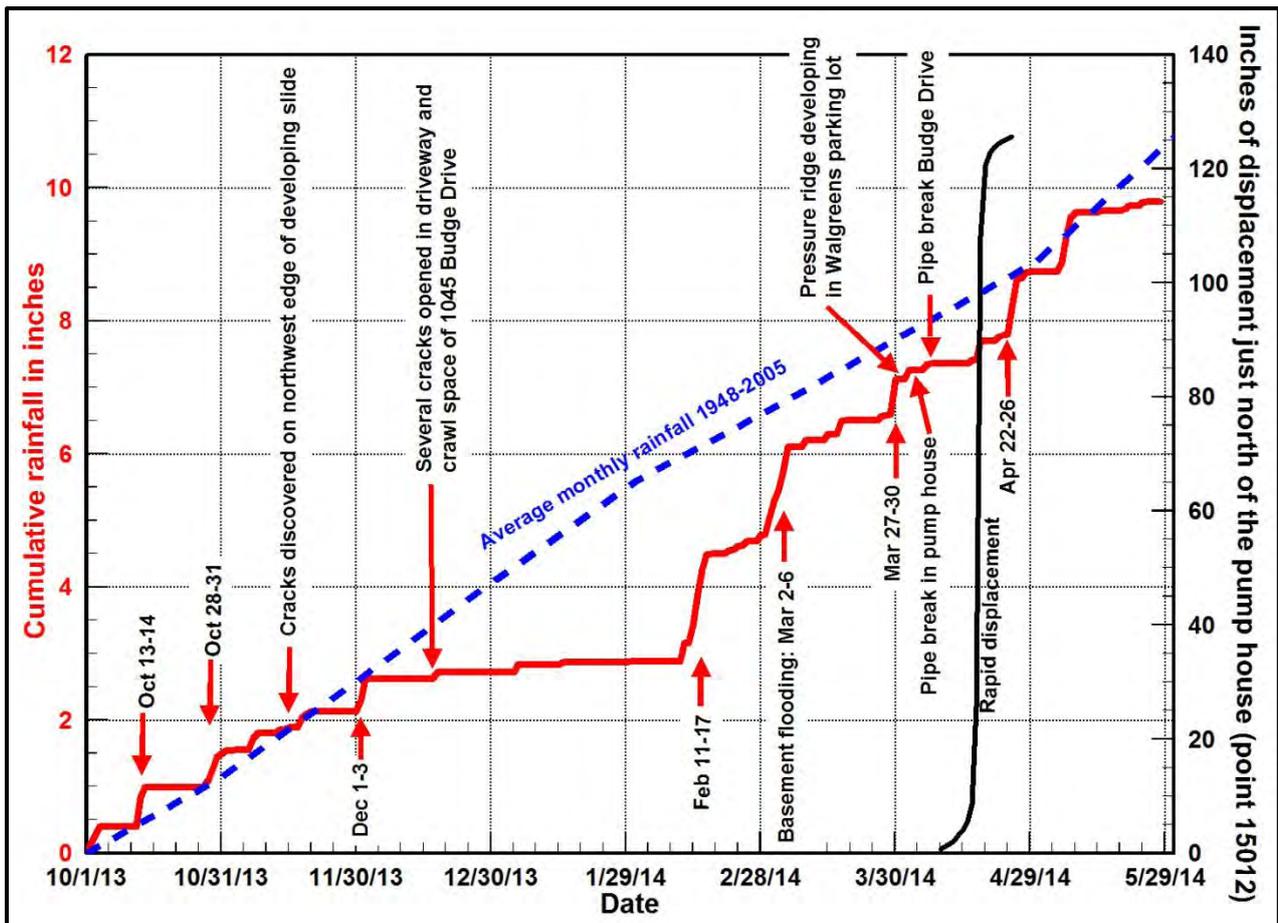
Figure 18: Rapid displacement of the town pump house southward toward West Broadway occurred after a much more rapid increase in spring rainfall than normal compounded by rapid melting of record snow cover over frozen ground causing the worst flooding of basements along Budge Drive remembered by residents who had lived there for many decades.

The red line in Figure 18 shows the cumulative rainfall measured on the north end of East Gros Ventre Butte from October 1, 2013 through May 30, 2014. The dashed blue line shows the cumulative average rainfall per month for this period. These data cover the period from August, 1948, through 2005 for the Town of Jackson (Western Regional Climate Center, 2014). Rainfall at a rate more than twice average began on February 11, 2014. From March 2 to 6, a particularly warm rain fell, melting snow still covering the hillside above Budge Drive. Residents say the ground was still frozen so that there were “sheets” of water from both rainfall and rapid snow melt flowing down the hill. At 7:30 am on March 6, residents at 1030 Budge Drive, just above and slightly west of the slide, put laundry in their washing machine in a dry basement. When they returned at 11 am to fetch the laundry there was two inches of water in the basement. Such flooding was reported from homes east of the slide to homes west of Budge Drive. Residents of the hillside for more than four decades could not remember similar flooding.

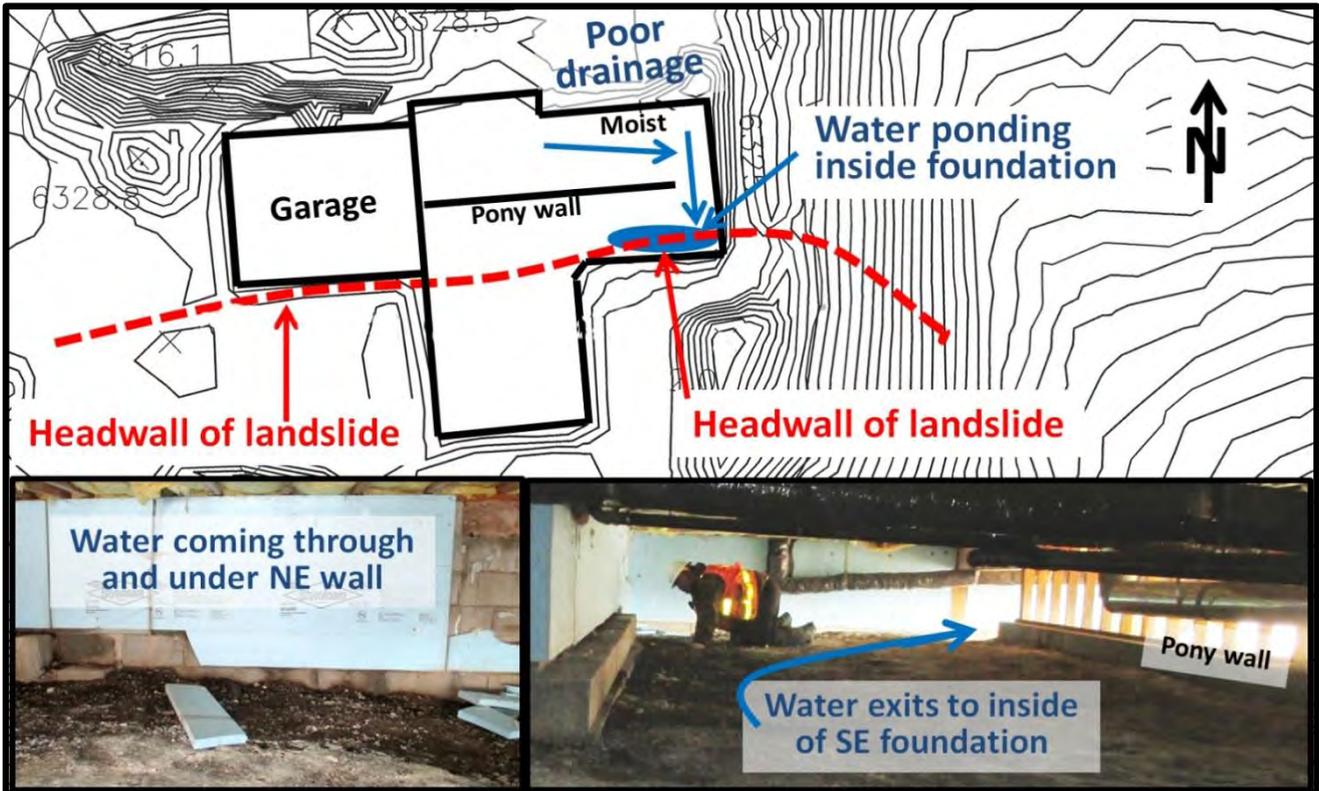
The north-sloping part of the roof at 1045 Budge Drive drains to the north of the house where there is no gutter, French drain, or any other type of drain to move the water away from the house. As a result, water tends to pond north of the house and especially north of the northeast part of the house. Here it permeates or flows under the foundation causing dampness observed in April, 2014 (Figure 19, lower left photograph). Then the water flows east and south past the east end of a pony wall, ponding just inside the southeast foundation of the home (Figure 19). At this point, there is only one way for the water to exit and that is downwards. Just north of the southeast foundation is precisely the headscarp of the Budge landslide (Figure 20), suggesting the possibility that this major leak could have been one of the factors causing the nucleation of the slide in 2011, the formation of the initial cracks that ultimately defined the northern physical extent of the slide.

Figure 19: Foundation of the home at 1045 Budge Drive plotted on a one-foot contour map showing where water flows around the pony wall to pond behind the southeast foundation. Picture lower left is looking north where moisture regularly comes through or under the concrete block foundation. Picture lower right is looking east.

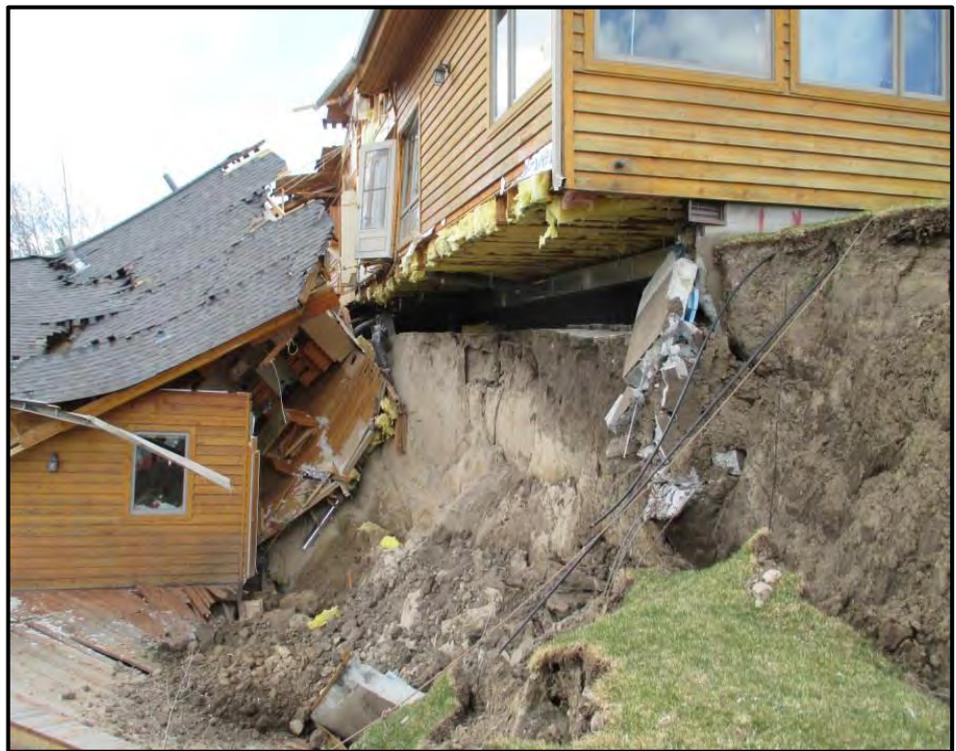
Figure 20: Headscarp of the landslide directly under the inside edge of the southeastern foundation of the house at 1045 Budge Drive

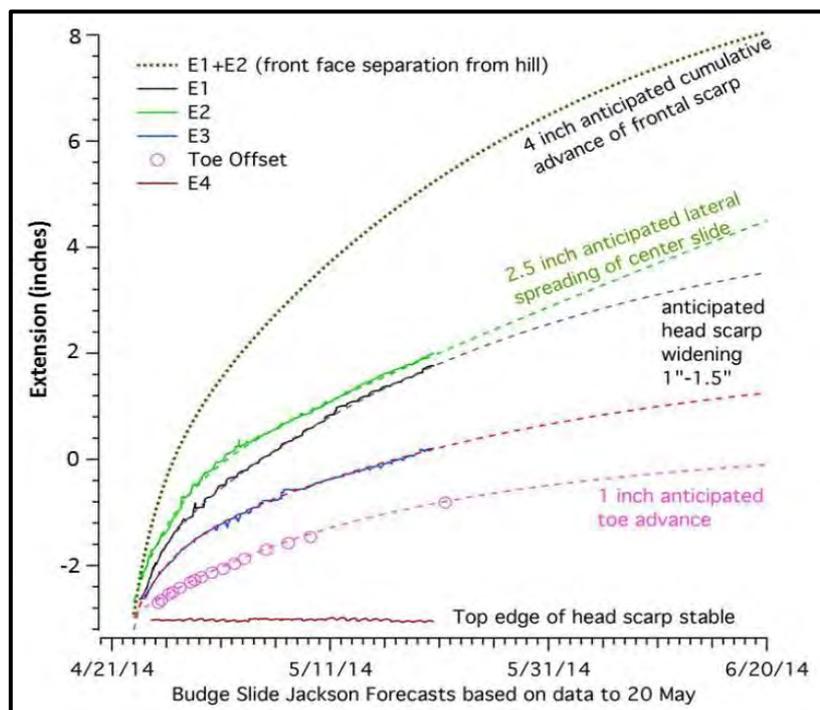
Figure 21: Extension measured by four instruments spanning the headscarp of the Budge Slide and modelled advance of the frontal scarp. Observations shown were from April 23 through May 20, 2014.
