# Geologic Report on the Slide near Budge Drive, Jackson, Wyoming to the Jackson Town Council by the Geologists of Jackson Hole

## Abstract

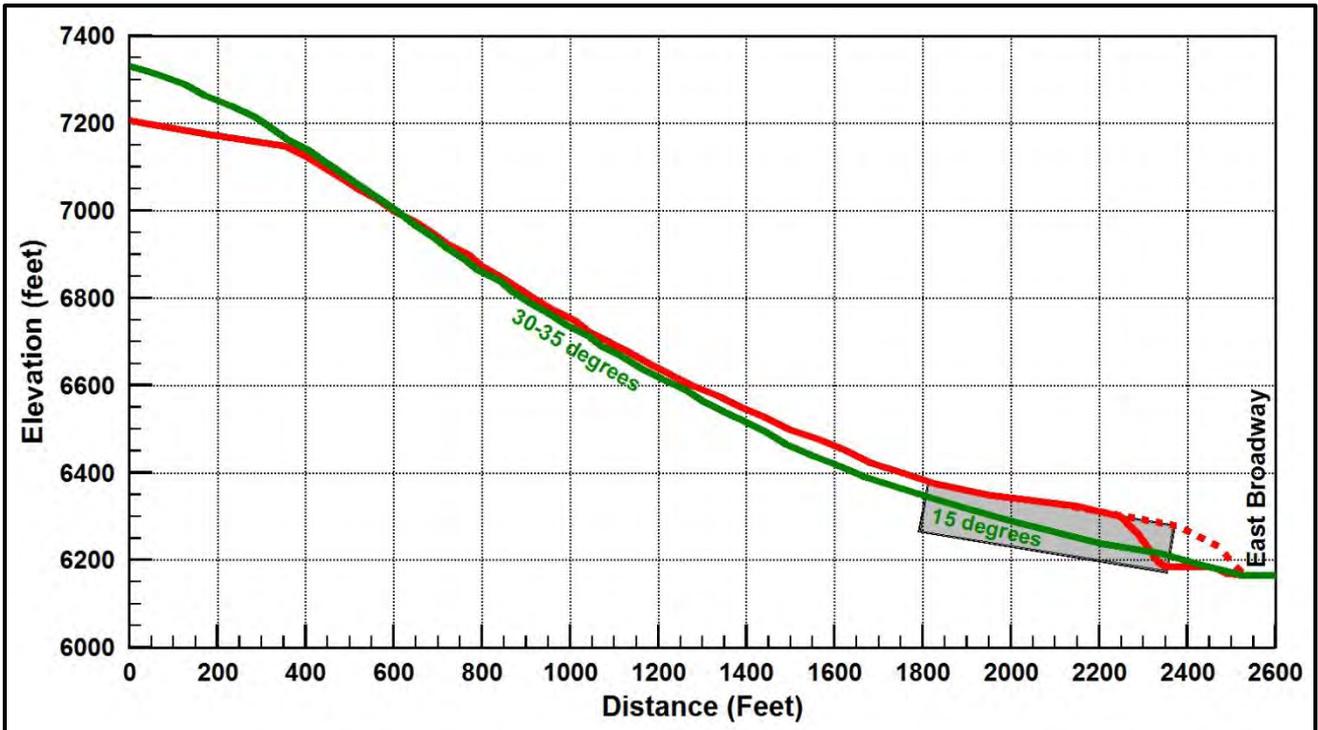
Figure1: Topographic profiles of the south slope of East Gros Ventre Butte north of West Broadway at Virginian Lane (green line) and at Scott Lane (red line). The dashed red line shows the slope north of Scott Lane before extensive quarrying based on the 1963 USGS topographic map. The gray-shaded rectangle shows schematically how a 140-foot thick slab of andesite might underlie the current slope. The locations of the profiles are shown on a map in Figure 2.

The green line in Figure 1 shows a topographic profile of the south slope of East Gros Ventre Butte north of West Broadway at Virginian Lane (green line CD in Figure 2). This profile is typical of the slopes surrounding and within Jackson Hole. The angle of repose is 30 to 35 degrees on the upper slope at distances plotted between 800 and 1200 feet (along the horizontal axis) and decreases to 15 degrees between 1800 and 2200 feet (along the horizontal axis). Near the top of the slope, the angle of repose is determined primarily by the coherency of the soil/rock formation – how well it holds together – how slowly it is eroded. Further down slope, debris accumulates that is less coherent, less consolidated, and the angle of repose is determined more by the support of

The gray-shaded rectangle in Figure 1 shows a possible extent in the north-south direction for this block relative to current topography. This block appears to have slid down the butte as a unit long before settlement of Jackson Hole, bringing economically valuable andesite road metal, which is broken rock and sandy soils used in the foundations of roads and buildings, close to the valley floor where it could be easily quarried. The present day Budge Drive landslide involves the southern part of this block but also other materials to the east and below the slide block. Thus the recent landslide does not appear to be a simple reactivation of the pre-settlement slide block, but was formed within the pre-existing slide block and surrounding material. The east-west extent of the current slide is coincident with and therefore appears to result from the east-west extent of the cliff face created by quarrying.

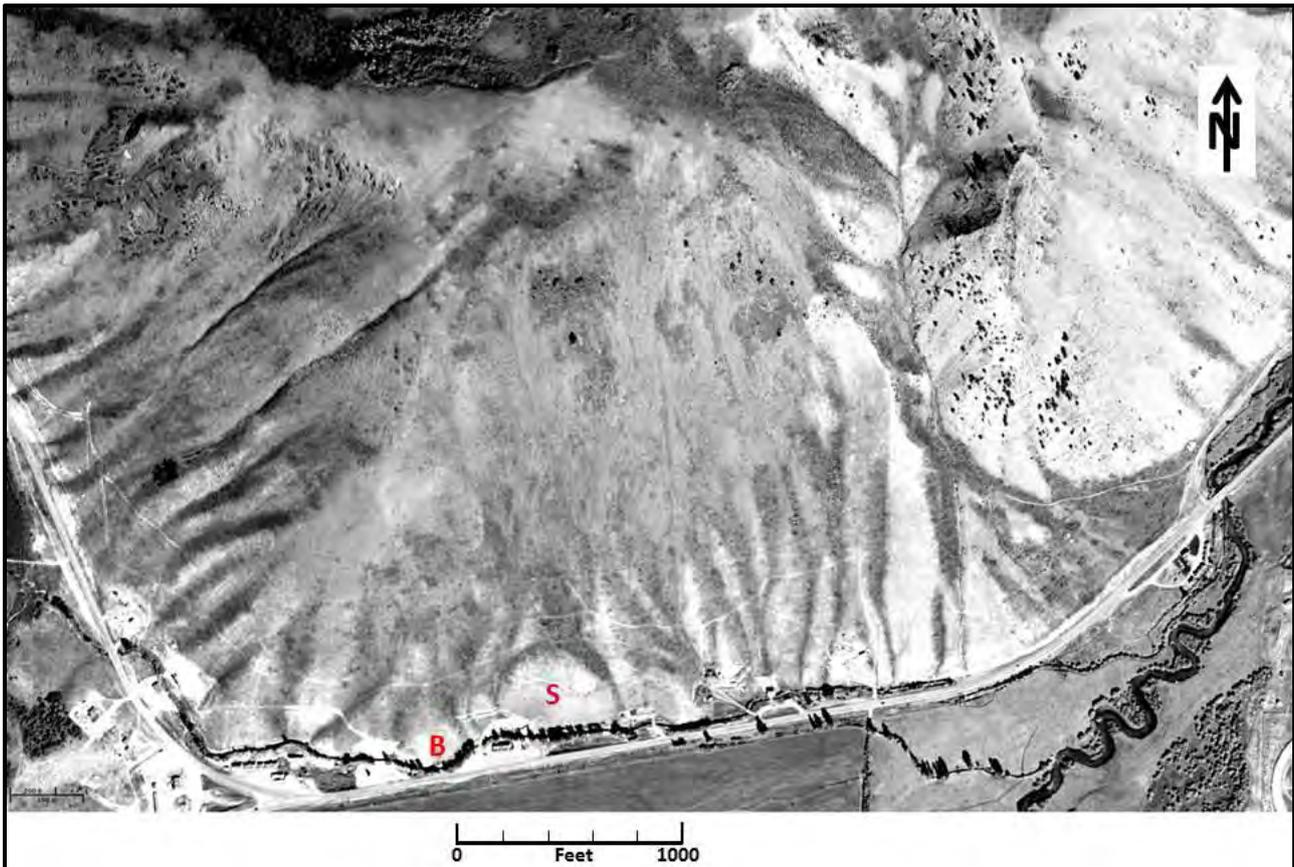
Figure 6: Aerial photograph taken in 1955 showing the south end of East Gros Ventre Butte, the region of the future Budge Slide (S) and the region of the future branch of The Bank of Jackson Hole (B).

Figure 6 shows a 1955 aerial photograph of the south end of East Gros Ventre Butte just west of the town of Jackson. The location where the Budge Drive Slide would later occur, marked with a red “S”, includes most of the land within the light colored circular feature in the lower central part of this image. This circular feature looks like a dish or depression to many eyes, but it is actually an area that is elevated compared to the adjacent slope. The darker areas surrounding it are vegetation showing the primary routes for drainage of water from off the higher slopes of the butte. This circular feature appears much lighter because there is less vegetation on it, and less moisture in its soil. The brightest white areas, such as just southwest of the “S” and further to the west, though which an irrigation ditch can clearly be seen to run (red line Figure 7), are lands that were graded by the summer of 1955 when this photo was taken, for construction or to extract road metal, which is broken rock and sandy soils used in the foundations of roads and buildings.

The bench on the south end of East Gros Ventre Butte, extending from the region north of Virginian Lane to the west of Budge Drive, appears to have been formed by large blocks and related debris sliding down the butte. This bench is a partially consolidated body of landslide debris. The largest block appears to be in the region labeled “S” in Figure 6. This block is more than 400 feet in

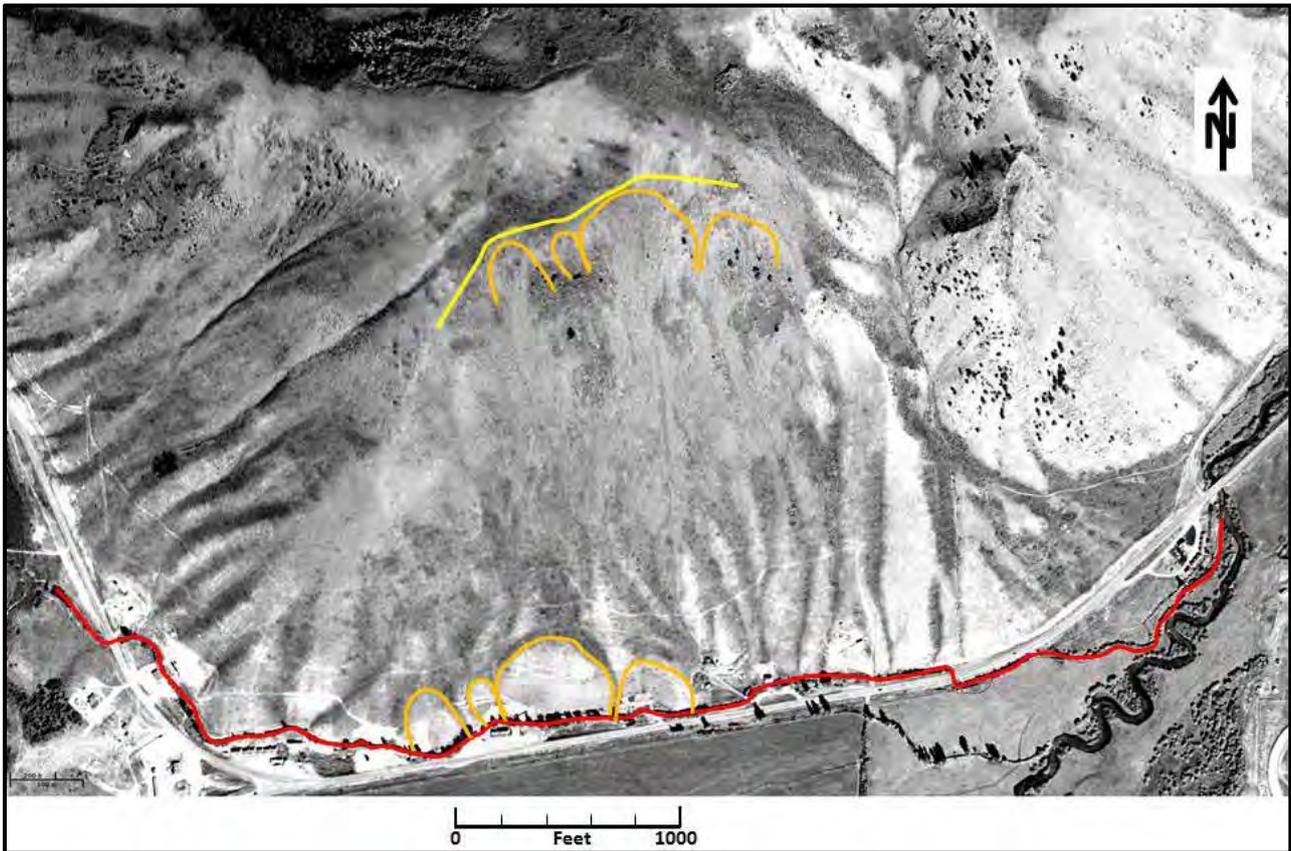
Figure 7: Aerial photograph of the southern end of East Gros Ventre Butte taken in 1955. The lower arcuate orange lines outline the geomorphic anomalies of poorly vegetated parts of the hillside. These are likely to contain the majority but not all of the blocks of andesite and conglomerate that appear to have slid down the butte from somewhere in the vicinity of the upper arcuate orange lines. The yellow line shows a cliff facing southeast. The red line traces an irrigation ditch dug before 1910.

The breadth, shape, and gray shading of the future quarry and later slide area is distinctively different from any other area shown in this photo. There is one area to the east and two to the west shown by orange lines in Figure 7 that are similar but smaller. The primary rock outcropping in these four areas is andesite, a light-gray colored extrusive volcanic rock, and conglomerate that, as described above in the section on geology of the area, is found near the top of East Gros Ventre Butte above the Budge Drive area and near the top of High School Hill to the southwest. The yellow line in the upper part of Figure 7, drawn along the rapid break in slope near the top of the south face of East Gros Ventre Butte, shows where the topographic contours smoothly running northwest-southeast to the left of the line suddenly change direction along a cliff. The lower group of orange lines has been duplicated and moved without rotation up the butte and slightly east to show where these blocks of andesite could have come from, and likely why the yellow line has the deflection in it. The blocks may have slid down the slope together or separately. The upper orange lines merely show the simplest of many possible points of origin and possible number of slide blocks. What is clear from the geology is that these andesite blocks must have slid down the butte in the past. Love and Albee (1972) described the quarry in the main block as “Q5. – County quarry ... Rock quarried is highly shattered by Quaternary faulting and breaks into angular fragments commonly less than 6 inches in diameter; used in road construction.”

the east-west direction, 500 to 600 feet in the north-south direction, and, based on recently acquired drill cores, on the order of 140 feet thick. Drill-core data also show that the andesite block extends to the north of the geomorphic anomaly shown in Figure 7, under the vegetated area where the ground slope is closer to horizontal than areas above.

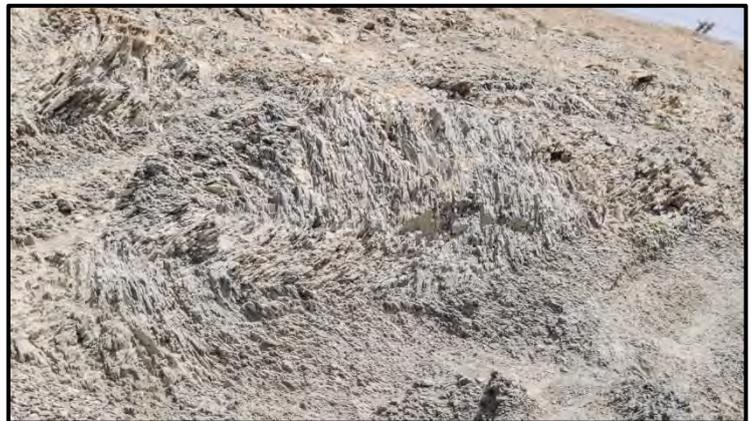
Figure 8: Flow-foliated andesite in the cliff just north of the entrance to the upper parking lot for Sidewinders.

- The andesite is highly flow-foliated (layered and folded), as is well seen in the outcrop above Budge Drive in the cliff face (Figure 8) and as shown by the less than 50% average recovery of andesite in the LT-4 and LT-5 cores. These flow-foliation surfaces are open conduits that allow water to readily move downward through the andesite to reach the underlying clay-rich layers. Once water reaches to a clay-rich layer, it would tend to then flow on top of the clay rich strata, providing the natural slip surface that the present day slide is utilizing.

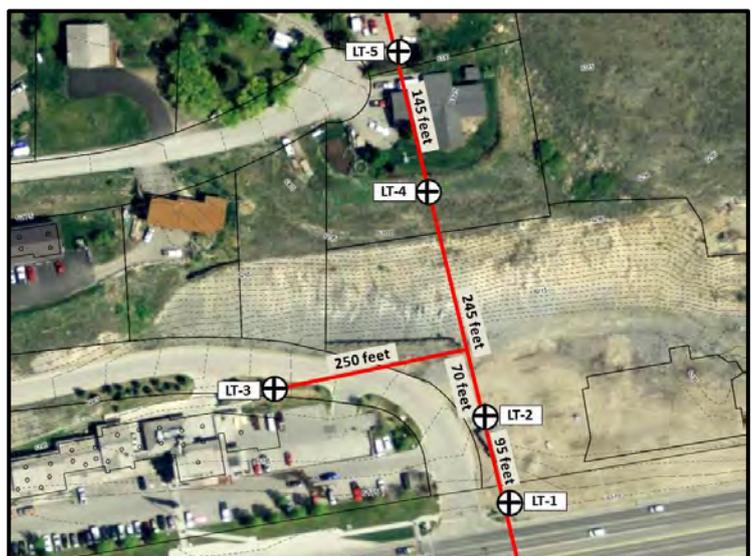
Following the most rapid slip of the Budge Drive landslide between April 15 and 19, 2014, Landslide Technology had five core holes drilled within or adjacent to the slide block (Figure 9). These holes were continuously cored and provide an excellent record of the rock involved within the landslide as well as what underlies the slide block and the lower slopes of the southern face of East Gros Ventre Butte. Our descriptions of these five cores (LT-1, 2, 3, 4, 5) are given in the Addendum to this report. Figures 10 and 11 show two similar but slightly different interpretations of a cross-section of the slide block based

Figure 9: Location of drill holes LT-1, 2, 3, 4, 5, and the nearly north-south cross section (solid red line) on an air photo taken in 2013. Lot and parcel lines are shown in black including an outline of the Walgreens store completed in late 2013.

on these core data, data observed at the surface, and known geologic history. The cross-sections are in a location (Figure 9, red line through LT-1, LT-2, LT-4, LT-5) similar to that shown in Figure 4 extending from the intersection of the east side of Budge Drive with West Broadway, through the cliff, past the house on the hill at 1045 Budge Drive that was destroyed by the landslide.

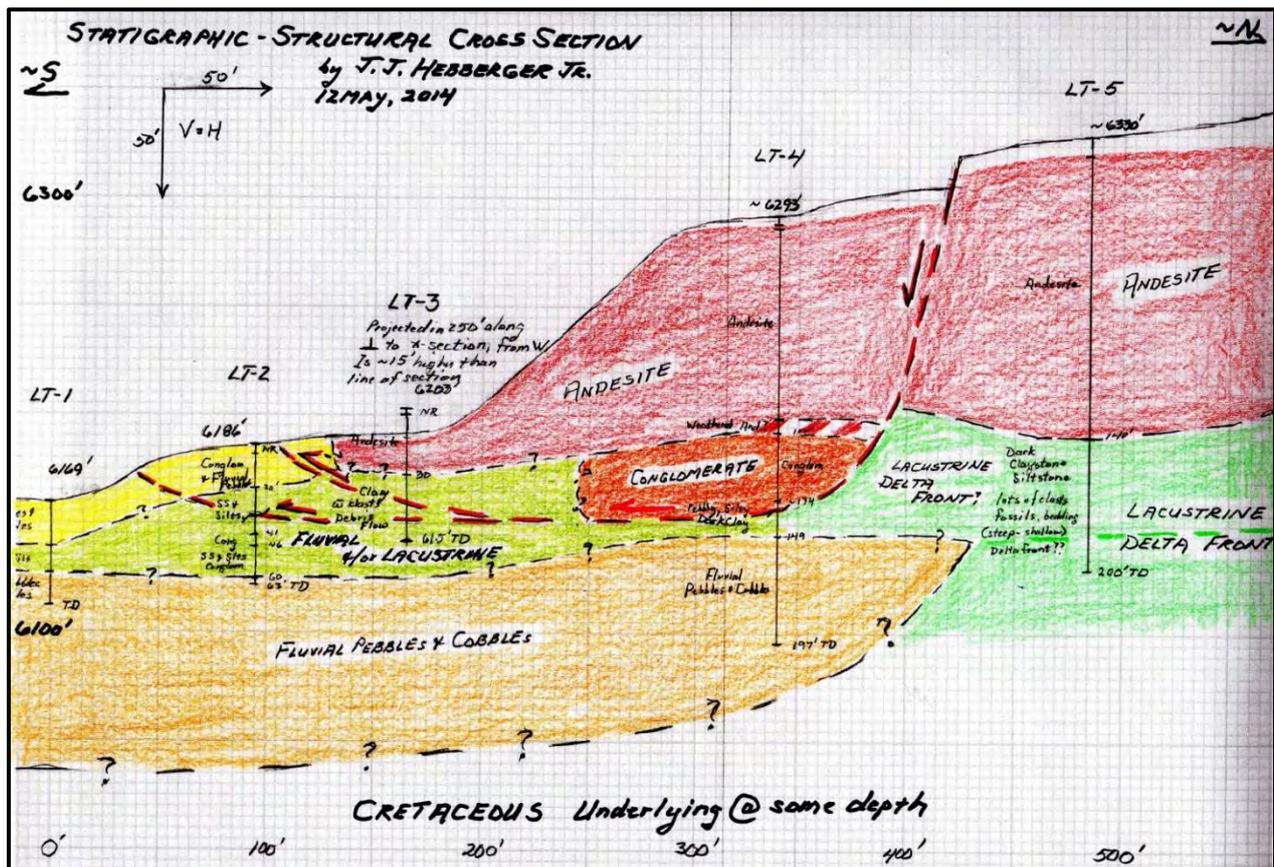
Figure 10: Initial interpretation of the core and surface data from LT-1, 2, 3, 4, & 5 core holes.

The interpreted setting, which is similar to the geomorphology seen today, and the type of sediments encountered in the "Lacustrine Delta Front" and "Fluvial &/or Lacustrine" strata indicate that it can be expected that these sediments extend east and west along the lower flank of East Gros Ventre Butte. Even where there is no older slide block on top of them, the colluvium forming the lower flank of the colluvial-alluvial apron along the south flank of East Gros Ventre Butte is likely also to rest directly on top of these older sediments. So while there is no incentive to drill expensive core holes east or west of the current slide block it should be expected that if they were drilled the "Lacustrine Delta Front" and the "Fluvial &/or Lacustrine" clay, silt, and sand rich facies would be encountered in those locations as they are in cores LT-5, LT-4, LT-3, LT-2, and likely LT-1.

The location of the slide (fault) surface for the present day slide block may reactivate a portion of the slide surface of the ancient slide block, but this appears largely because the ancient slide block came to rest on relatively impermeable and clay rich sediments (of the "Lacustrine Delta Front" facies). It is clear that the slide surface encountered in LT-4 and as depicted in Figures 10 and 11 is located at the base of the conglomerate that forms part of the old slide block, and therefore on top of the more clay-rich sedimentary layer below. But this is the only part of the ancient slide surface that could have been reactivated. The headscarp of the current slide block is in the middle of the ancient slide block that is largely andesite, is located approximately half way between core holes LT-4 and LT-5 (see Figures 10 and 11), so only the lower part of this old slide block is involved in the present day slide. The current slide has not caused ground movement at the LT-5 location and so the old slide surface, which is at approximately 140 foot depth in LT-5 at the contact between the andesite and the Lacustrine Delta Front, has not been reactivated.

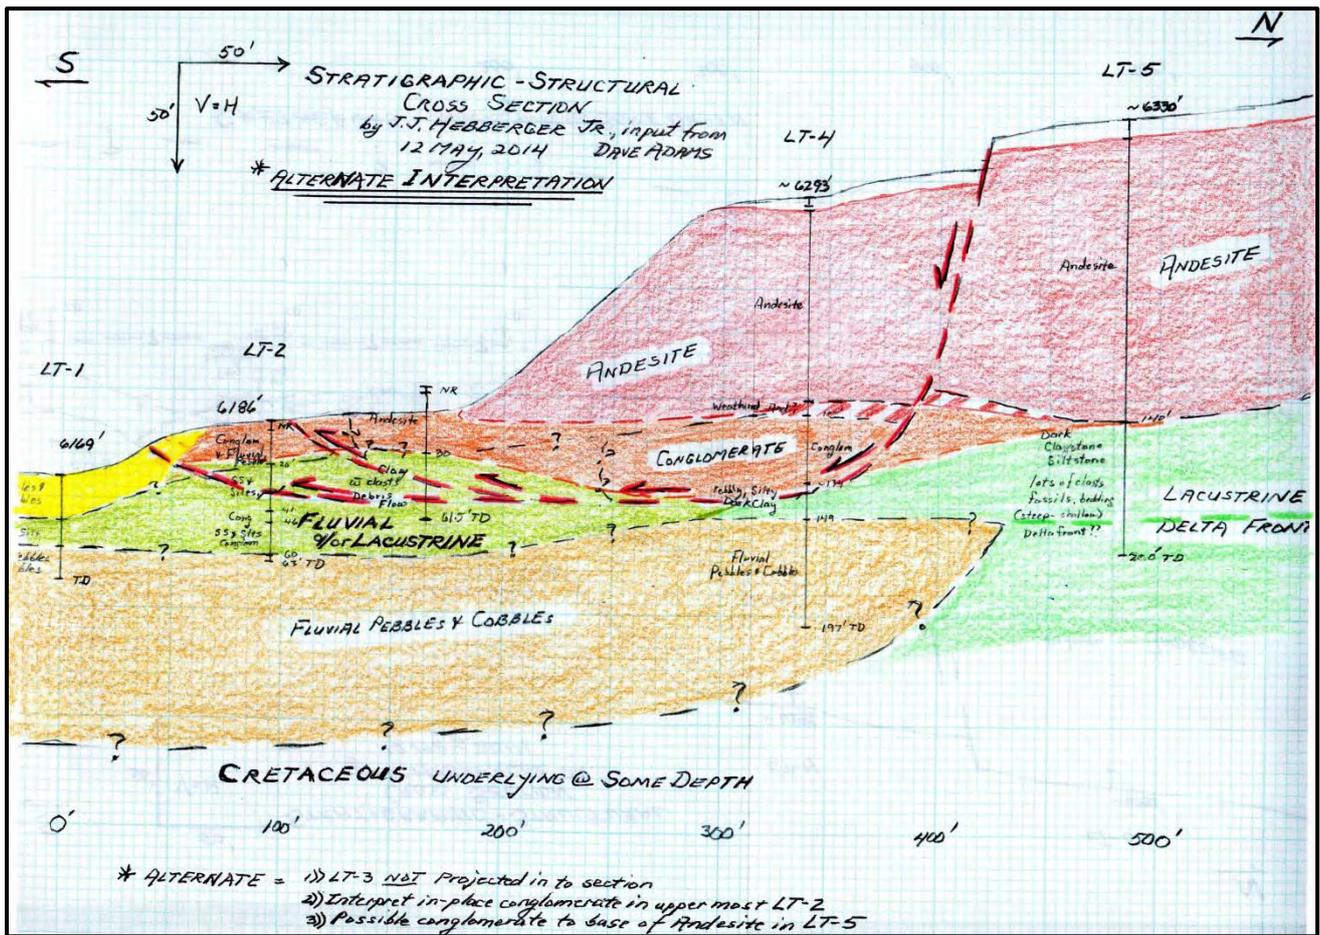
Figure 11: Alternate interpretation of the core and surface data from LT-1, 2, 3, 4, 5 core holes. 300,000 and 200,000 years ago.

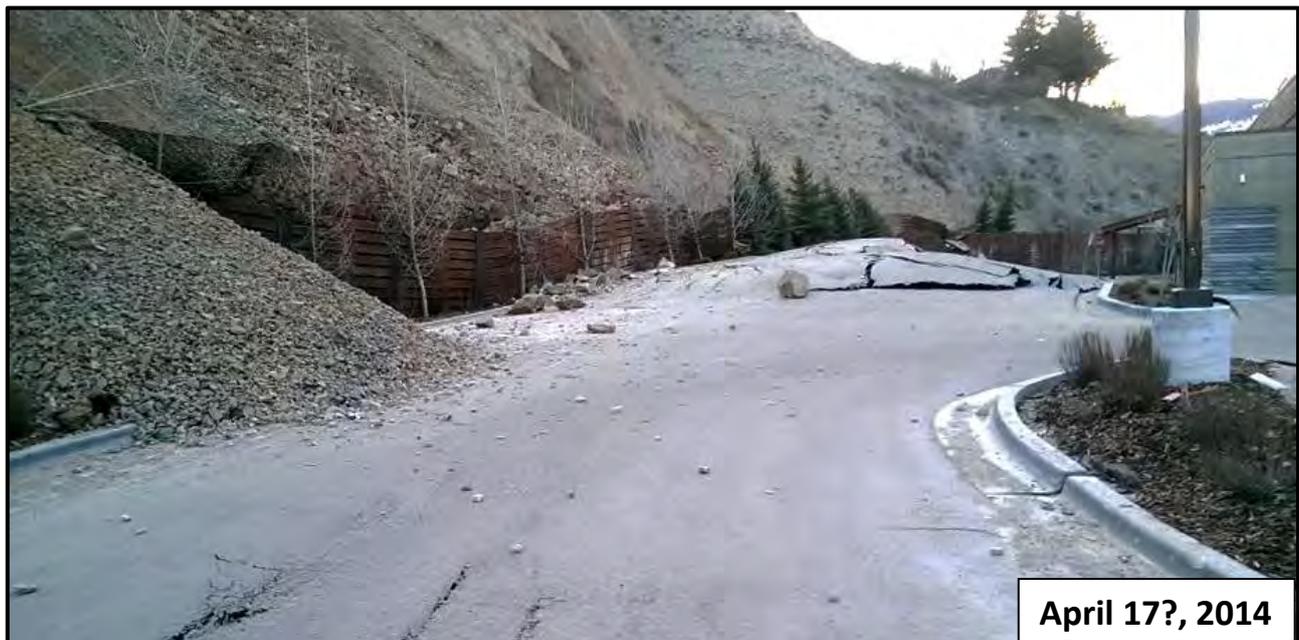
million cubic feet. This includes material removed in 2003 to create a parking area and access east of the Jackson Hole Athletic Club building formerly located east of Budge Drive. Reconstruction of Budge Drive in 2003, removed an additional approximate 0.3 million cubic feet. Removing 8 feet of material in 2011 in preparation for the construction of Walgreens totaled another approximately 0.6 million cubic feet of material, approximately 4% of the total material removed from the quarry area. Photographs in Figure 13, all looking east-northeast towards the same trees on the horizon, show that considerable slope debris falling from the quarry cliff was removed since 2001.

Photographs in Figure 13, all looking east-northeast towards the same trees on the horizon, show that considerable slope debris falling from the quarry cliff was removed since 2001.
